INDOOR AIR QUALITY ASSESSMENT

**Falls Elementary School
One Jackson Street
North Attleborough, MA 02760**

Prepared by:
Massachusetts Department of Public Health
Center for Environmental Health
Emergency Response/Indoor Air Quality Program
June 2005

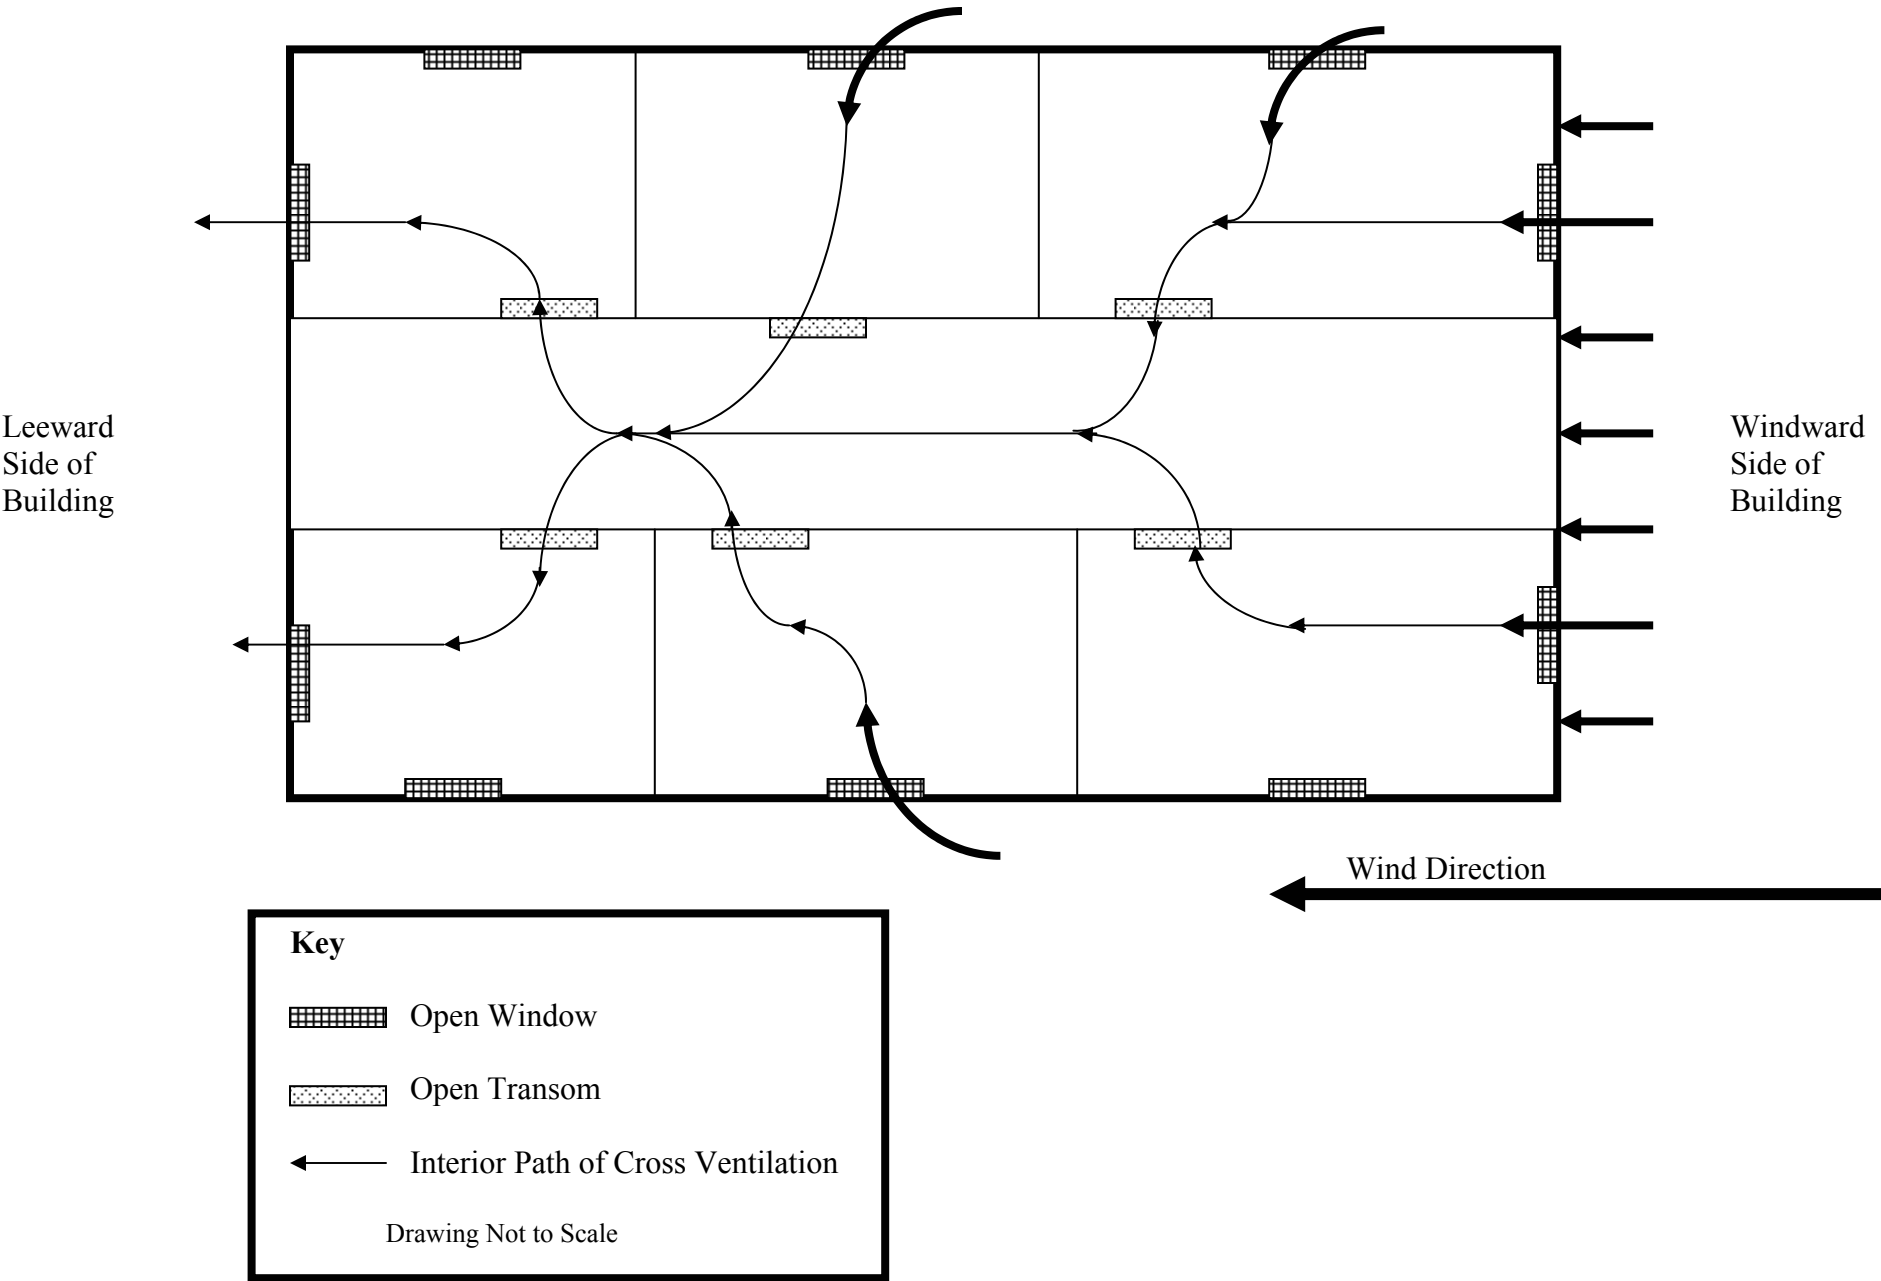
Figure 2

while maintaining a pathway for airflow. This design allows for airflow to enter an open window, pass through a classroom and subsequently pass through the open transom. Airflow then enters the hallway, passing through the opposing open classroom transom, into the opposing classroom and finally exits the building on the leeward side (opposite the windward side) (Figure 2). With all windows and transoms open, airflow can be maintained in a building regardless of the direction of the wind. This system fails if the windows or transoms are closed (Figure 3). Most of the transoms observed were inoperable and/or had hardware removed.

Cross Ventilation in a Building Using Open Windows and Transoms

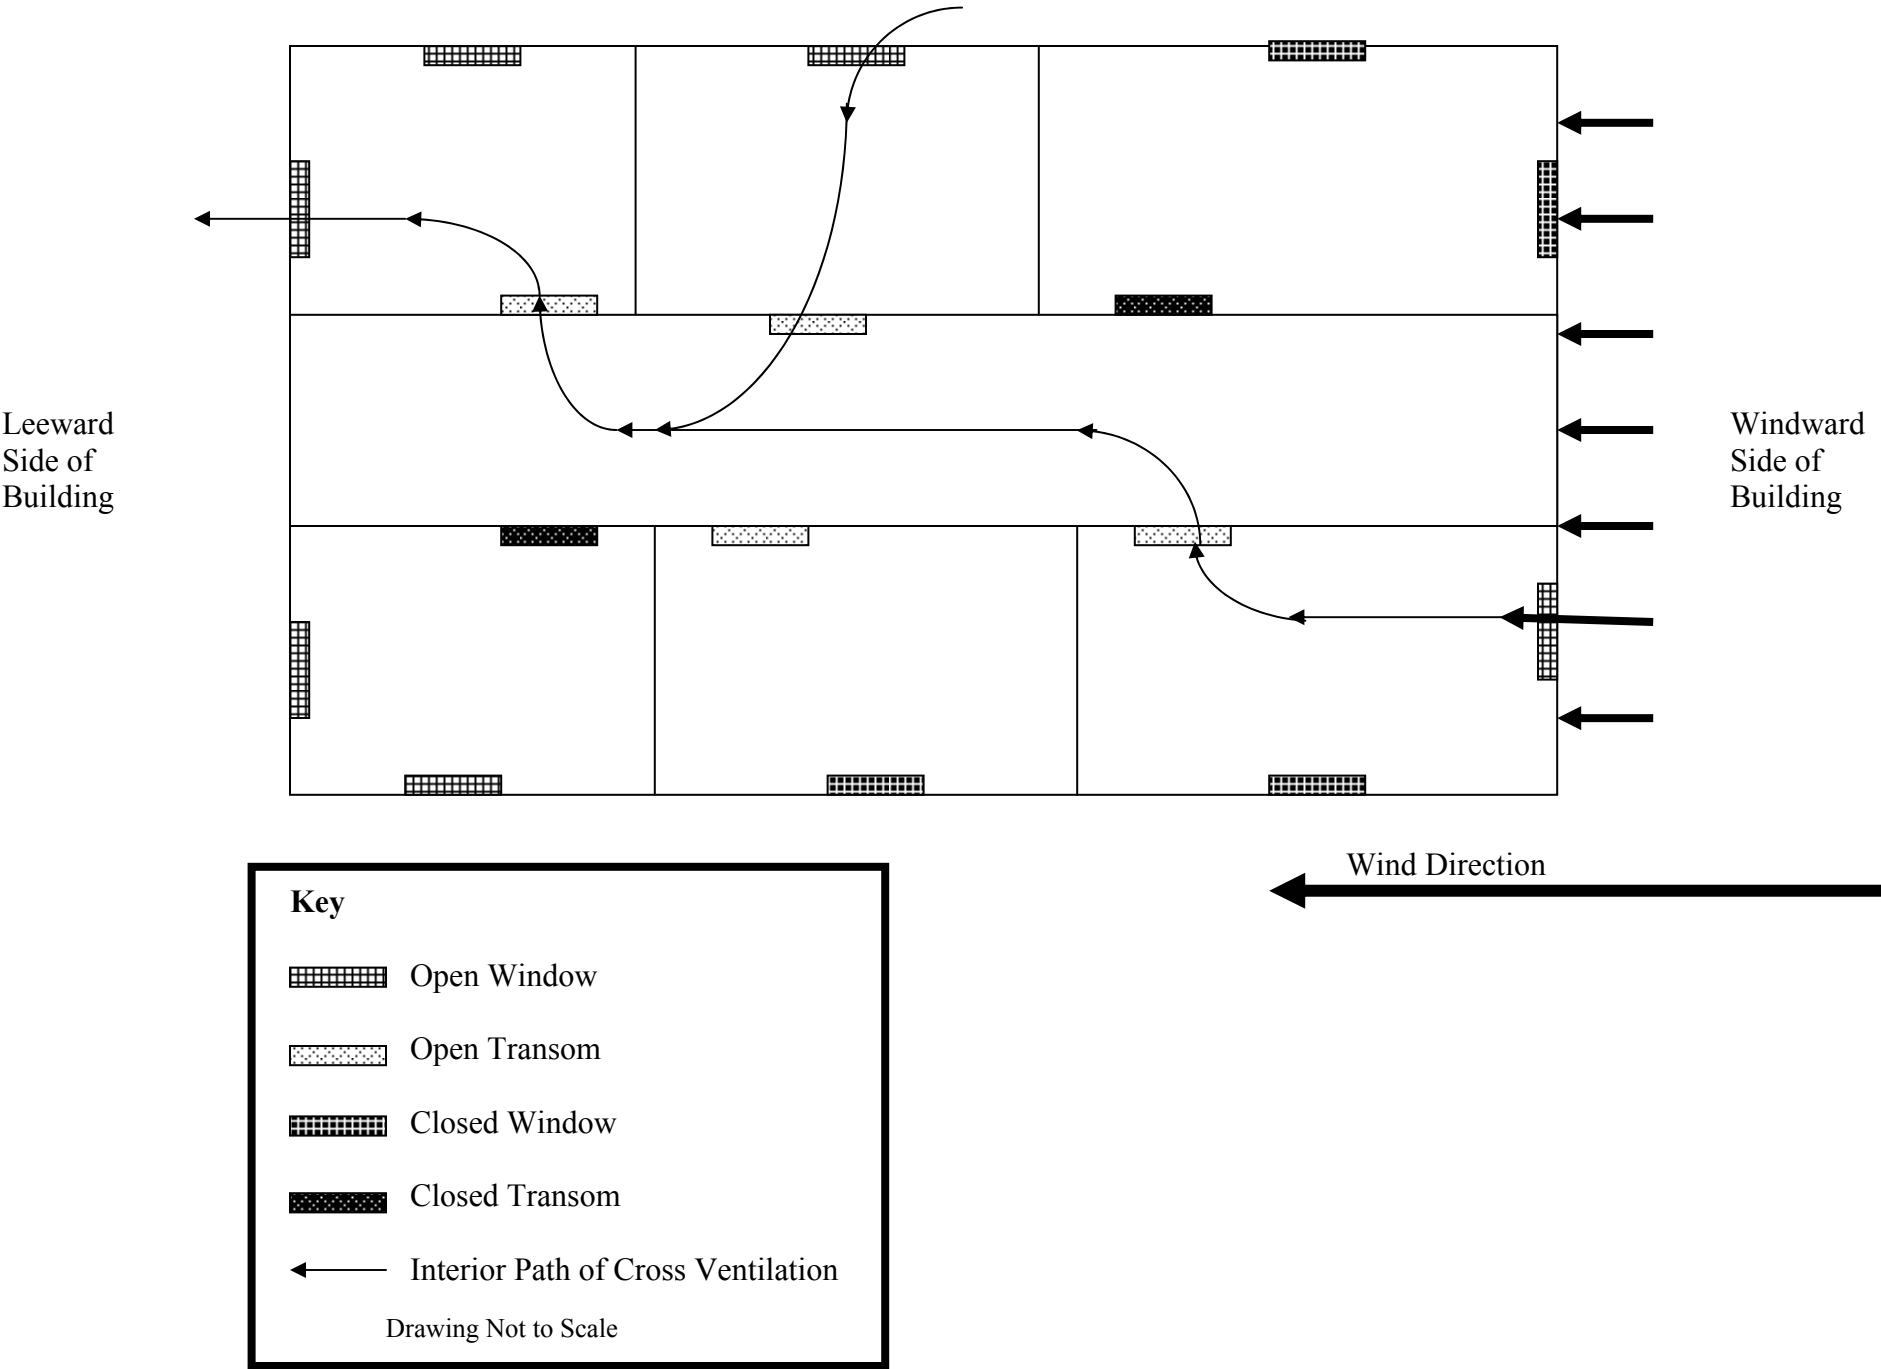
Figure 3

Inhibition of Cross Ventilation in a Building with Several Windows and Transoms Closed

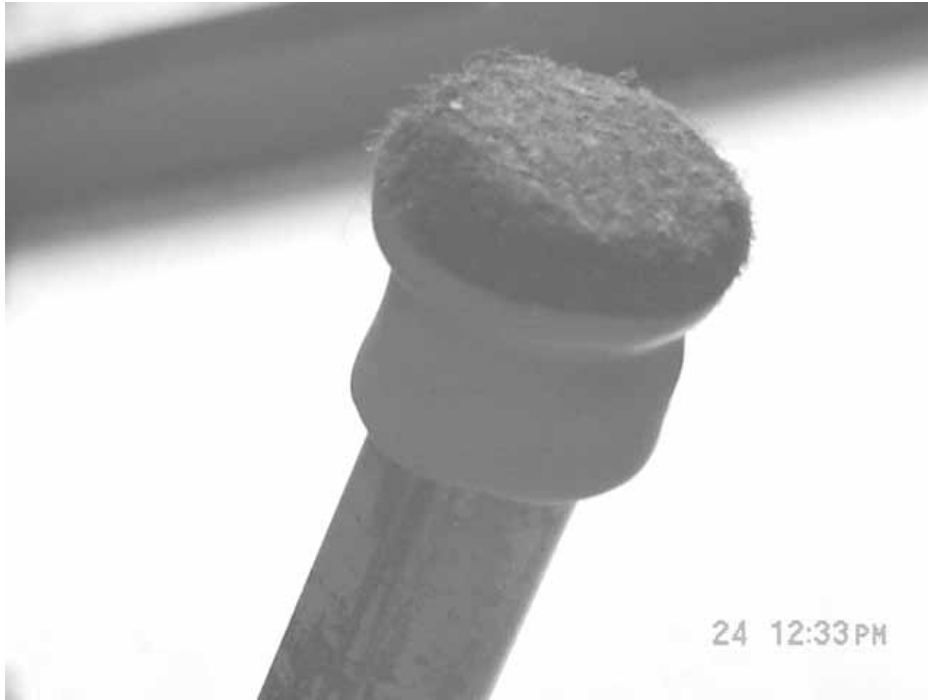
“Glides” for Chair Legs That can be Used as an Alternative to Tennis Balls

20. Consider discontinuing the use of tennis balls on walker legs to prevent latex dust generation. Alternative “glides” can commonly be purchased from office supply stores, see Picture 22 for an example.
